Water Quality Testing in the San Geronimo Valley

sponsored by the
San Geronimo Valley Planning Group

February 6, 2018

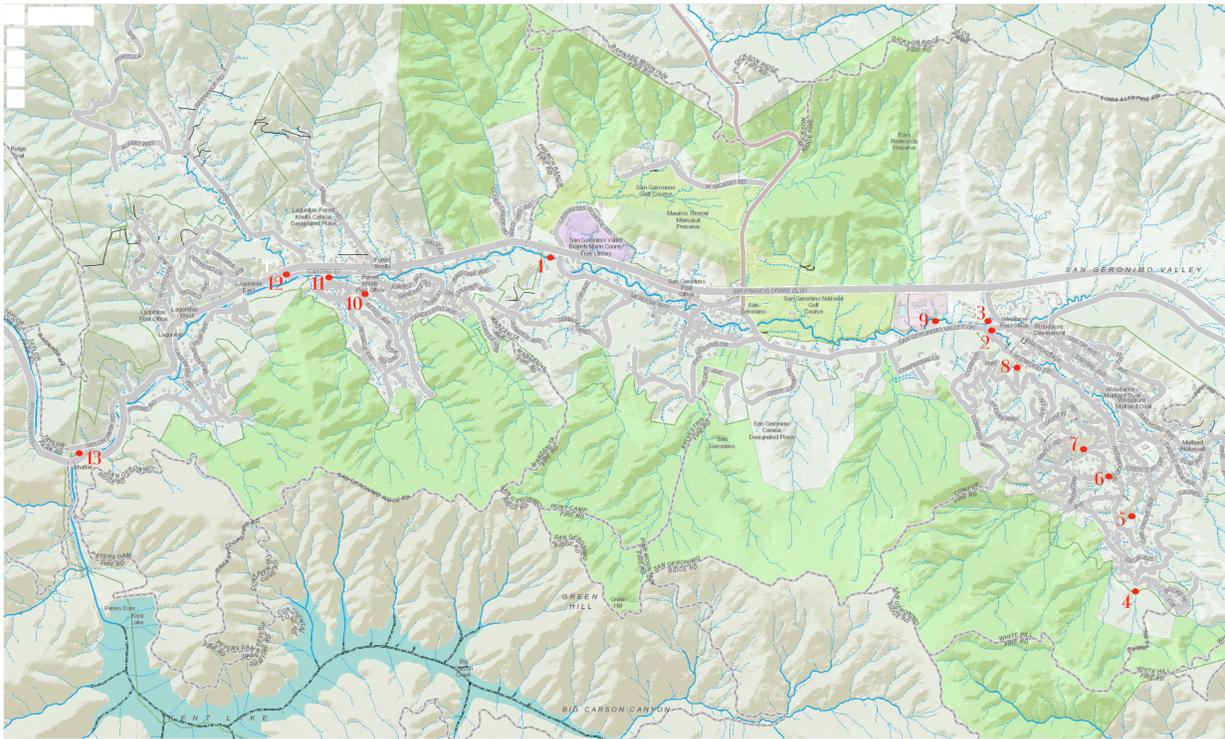
The following map shows the location of the sampling sites 1-13

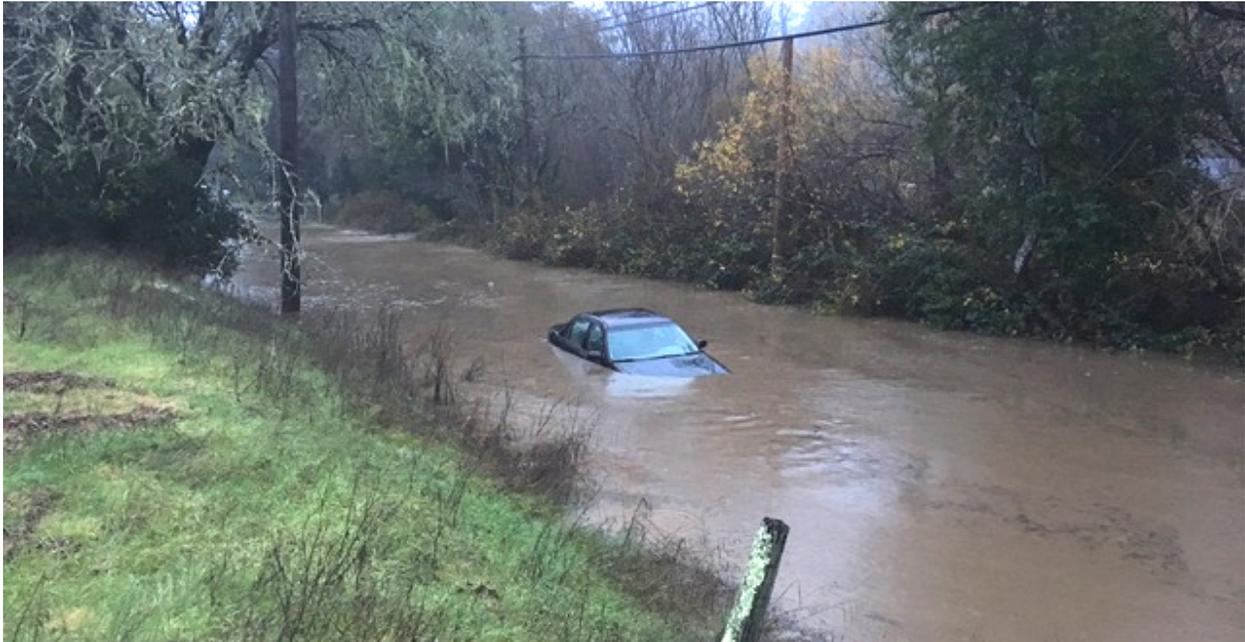
A flooded car photographed on Castro Street one day before the December sampling. This is approximately 1 mile downstream of sample site #1, one of three sites sampled at that time.

- In December water flow was extremely high when human source signal was detected. Approximately 1 mile downstream from Site #1 (Meadow Way) in Forest Knoll the area was flooded. Please refer to the photo on page 7.
